Project:
The Galleria
2244 East Sunrise Blvd
Fort Lauderdale, FL 33304
Contact: Mr. C. W. Greene

Start of the project : February 5th 2007
End of the project : February 9th 2007

Specification of work: Deoxidize and applying the Blygold case coating system on the outside of the air handling unit # 7 including the hood and the roof.

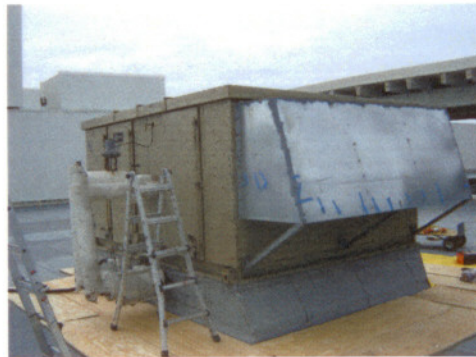
Technical service of the building shuts off the air handling unit.
Check if the situation meets the working descriptions (as in the quotation), incl. the air handling unit references. (Air handling unit # 7 with hurricane damage on the new roof)
Bring in the equipment and material needed.
Place wood around the air handler to protect the roof.

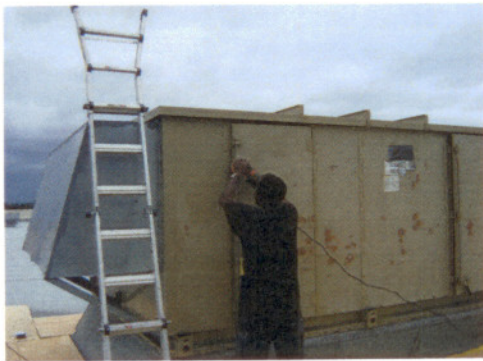
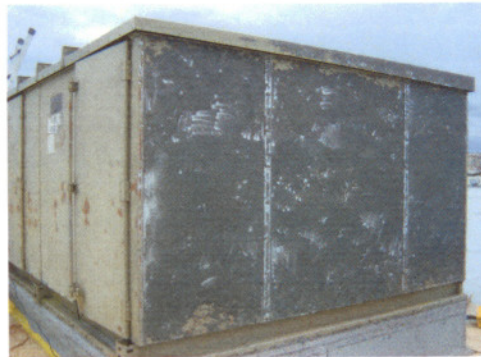
Check external casing.

Remove through sanding the loose paint and oxidation

Remove the dust after sanding.
